Constructional and architectonical description

Introduction

The gasholder was built in the years 1924-1925 in Czech town Ostrava – Vítkovice and served until 1998 when the iron production in adjacent blast furnaces was terminated after 162 years of operation. The out of service gasholder was converted into a new multipurpose hall used for cultural and social activities.

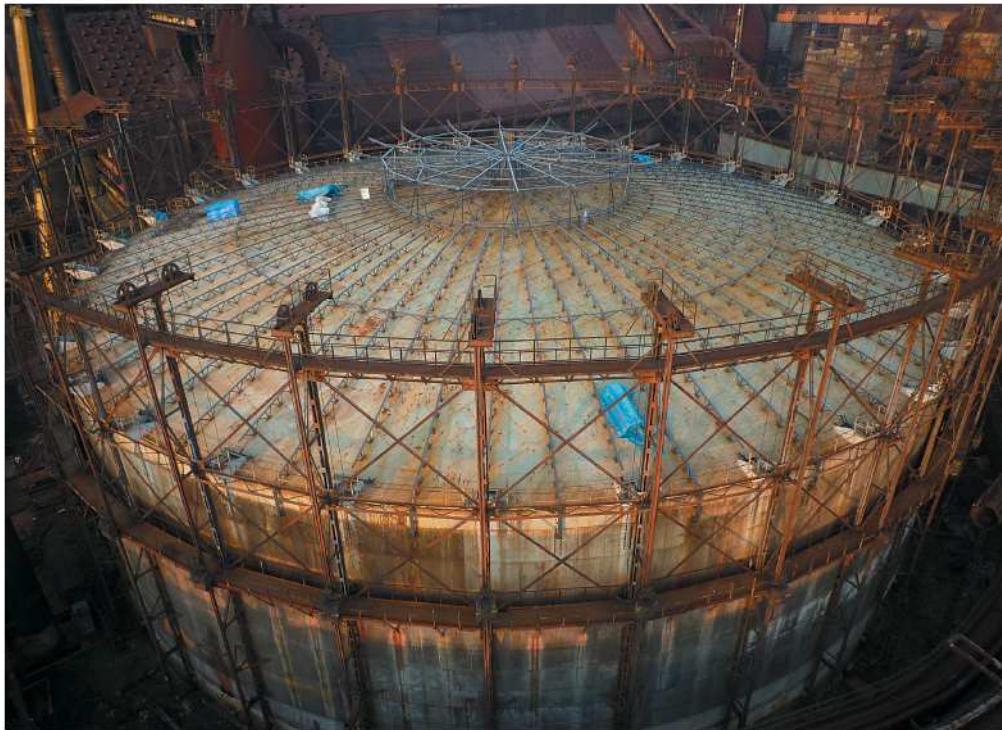
Vnější pohled na zdvih zvonu plynajemu s novým tamburem
Outside view to heavy lifting of the crown with new card cylinder

Heavy lifting of the crown

After reconstruction, the crown of the weight of 800tons was lifted into the height of 13 meters climbing onto 16 new lattice columns using 16 synchronized hydraulic jacks of load bearing capacity 100 tons. The legs of the lattice columns were situated on both sides of the crown and bracing members were gradually added below the rising crown. Lifting was completed within 11 days using 29 technological steps 460mm each. Then, additional 16 columns were added between the columns used for lifting. To ensure identical forces in all 32 columns, the new columns were activated by hydraulic jacks situated under the bottom part of columns.

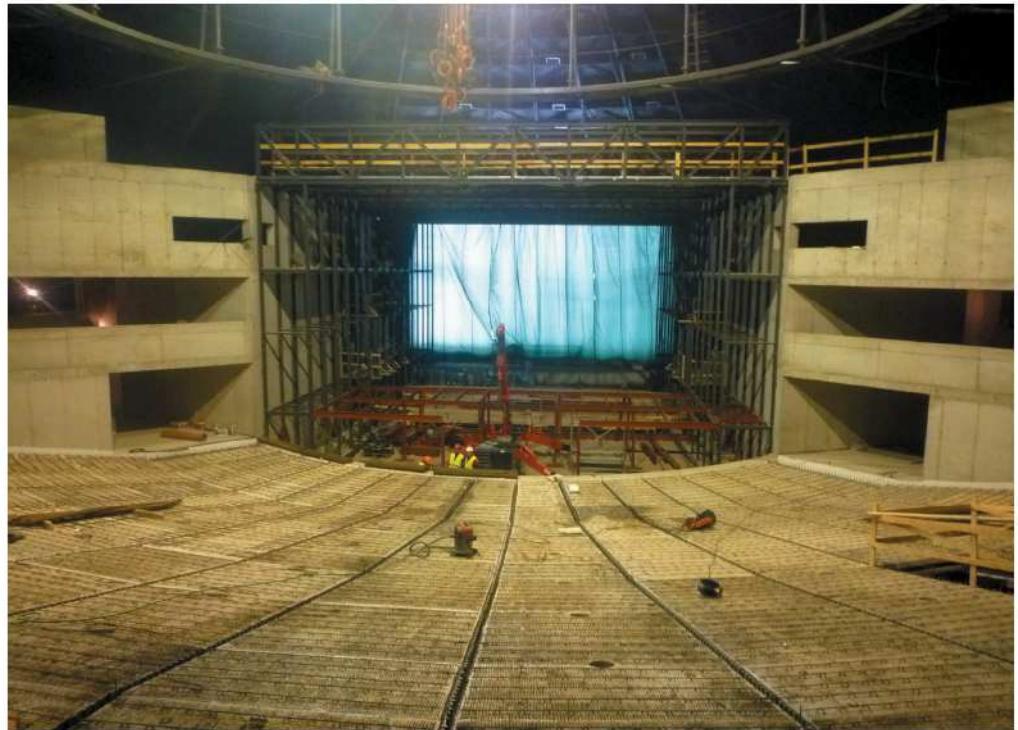
Hrubá stavba hlediště a jeviště
Carcassing of auditorium and stage

Steel structure of the auditorium

The scallop shaped auditorium with area of 1450 m² consists of 16 arched lattice girders radially situated towards the stage where they are anchored. They are supported by circular columns of length 22m at the back. Tangential bracing girders ensure the space acting of the structure. The structure is connected with the concrete slab consisting of 60mm thick filigrees with additional concrete plate of thickness 120mm.

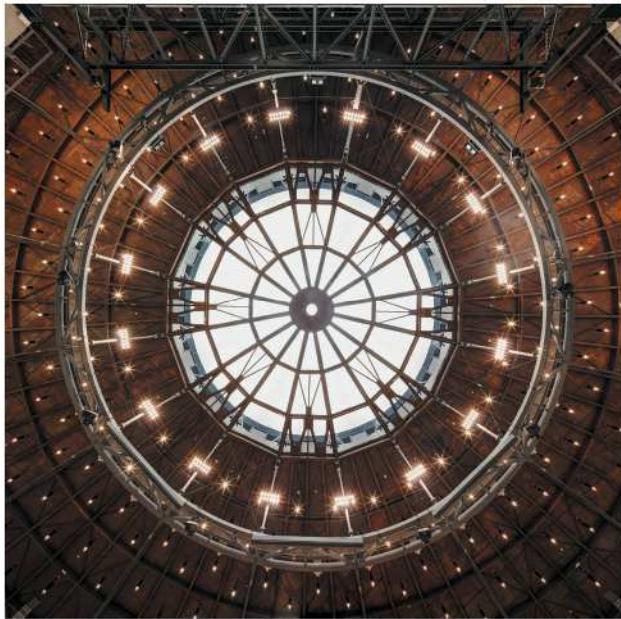
Pohled do klenby, vzpínadlo a otvor ve vrcholu
View to the dome, beam string structure and opening in the cap

The analysis of the roof shell of the crown under the new loading conditions and the detail inspection of the structure confirmed the necessity of reinforcement of the structure. The problem of the unsatisfactory roof shell elements was unconventionally solved by redistribution of internal forces thanks to additional prestressed space beam string structure. This space structure consists of 16 radial tie rods with threads M64 connected to the new central circular truss beam on the inner side and to the existing border ring of the roof shell of the crown on the outer side. The central truss beam has a shape of a circular ring of diameter 22.6 meters. This beam is braced to the roof by 16 columns and 16 diagonals.

This additional prestressed space beam string structure ensured favourable redistribution of the internal forces in the roof shell, so that most of the existing elements satisfied their new function, new loads etc. This solution was used instead of reinforcing almost all elements of the roof shell. The tensile forces in the border ring of the roof shell of the crown were reduced by about 25%; therefore it was not necessary to reinforce the 220 meters long ring and the existing radial beams. Only some tangential elements near the frame corners of the crown had to be reinforced. The tie rods were prestressed by turnbuckles, the axial stresses (forces) were measured on-line during erection by means of strain gauges. The optimal procedure of prestressing the tie rods was prepared using the influence matrix. This matrix was calculated on the basis of theoretical values and measured forces in the tie rods after erection.

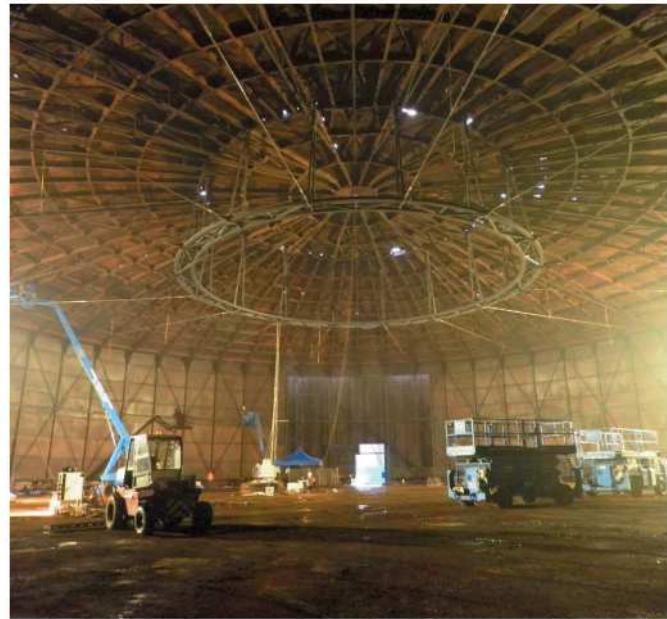
Montáž a předpínání vzpínadla
Erection and prestressing of the beam string structure
