EXCON a.s.
Sokolovská 187/203
190 00 Praha 9, Česká republika
Tel: +420 244 015 111
Fax: +420 244 015 340
e-mail: excon@excon.cz
www.excon.cz

Popis: Přepočítání chybně vyprojektované nosné ocelové konstrukce dvoulodní výrobní haly s jeřáby. Původní projekt nosné ocelové konstrukce zpracovaný jiným subjektem vykazoval chyby, na které se přišlo během realizace. Byl proto vypracován podrobný návrh opravy ocelové konstrukce s respektováním požadavku na minimalizaci nákladů na opravu a dodržení termínu uvedení do provozu. V době zahájení našich prací na přeprojektování konstrukce byla hala již smontována a opláštěna. Většina oprav se prováděla na místě, pouze nosníky jeřábových drah o délce 16 m byly pro opravu vráceny do mostárny. Během opravy již na drahách byly instalovány mostové jeřáby a hmotnosti až 65 t, které bylo náročné během rekonstrukce přesouvat, protože dráha po opravě měla niveletu kolejnice výše, než před opravou.

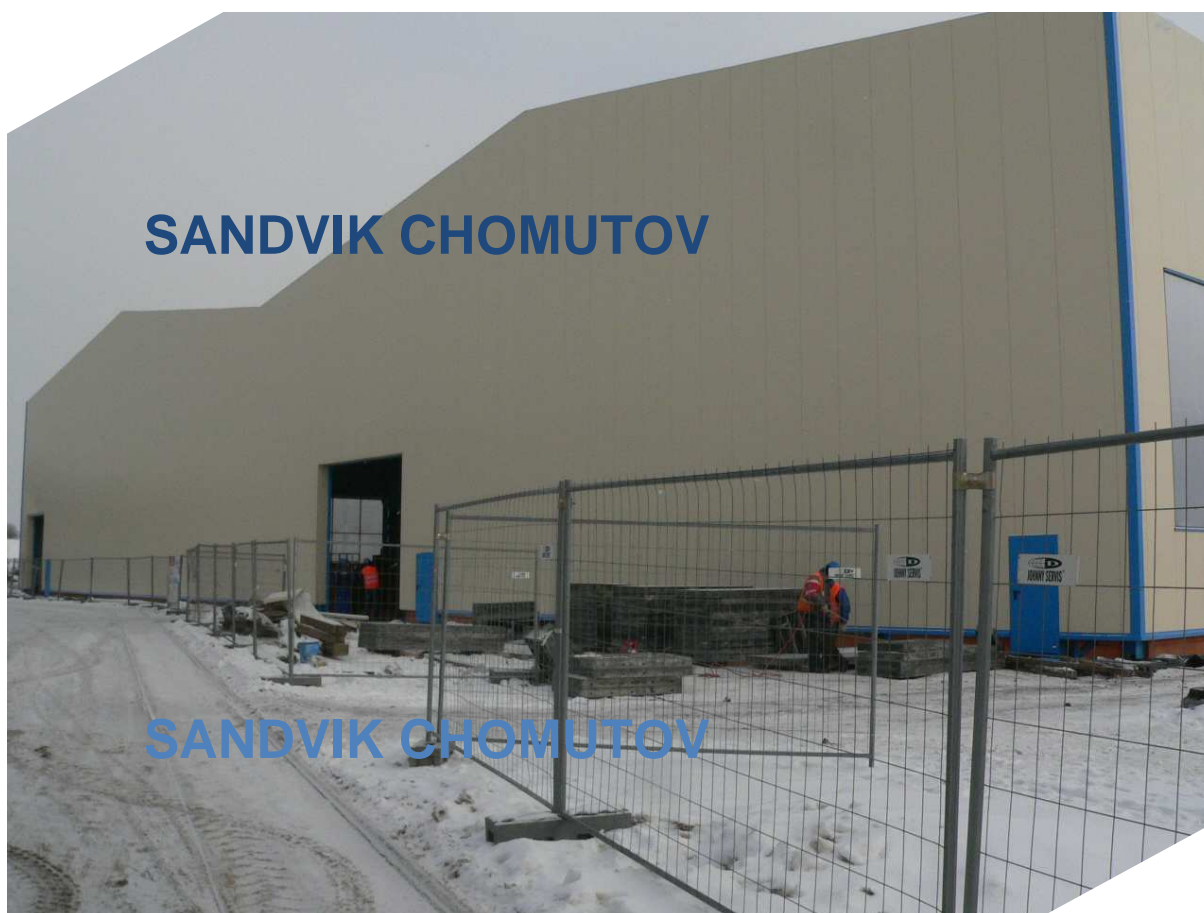
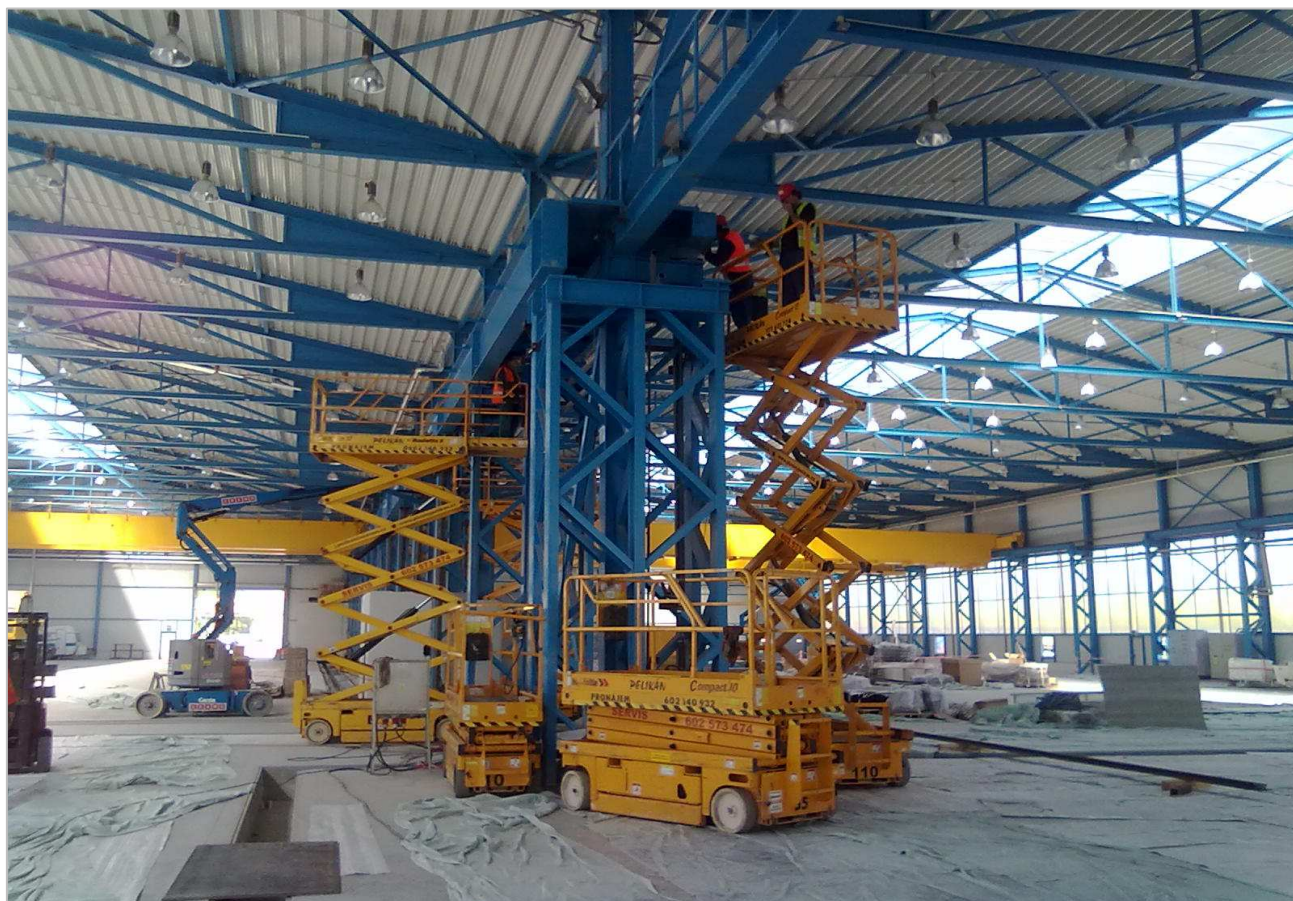
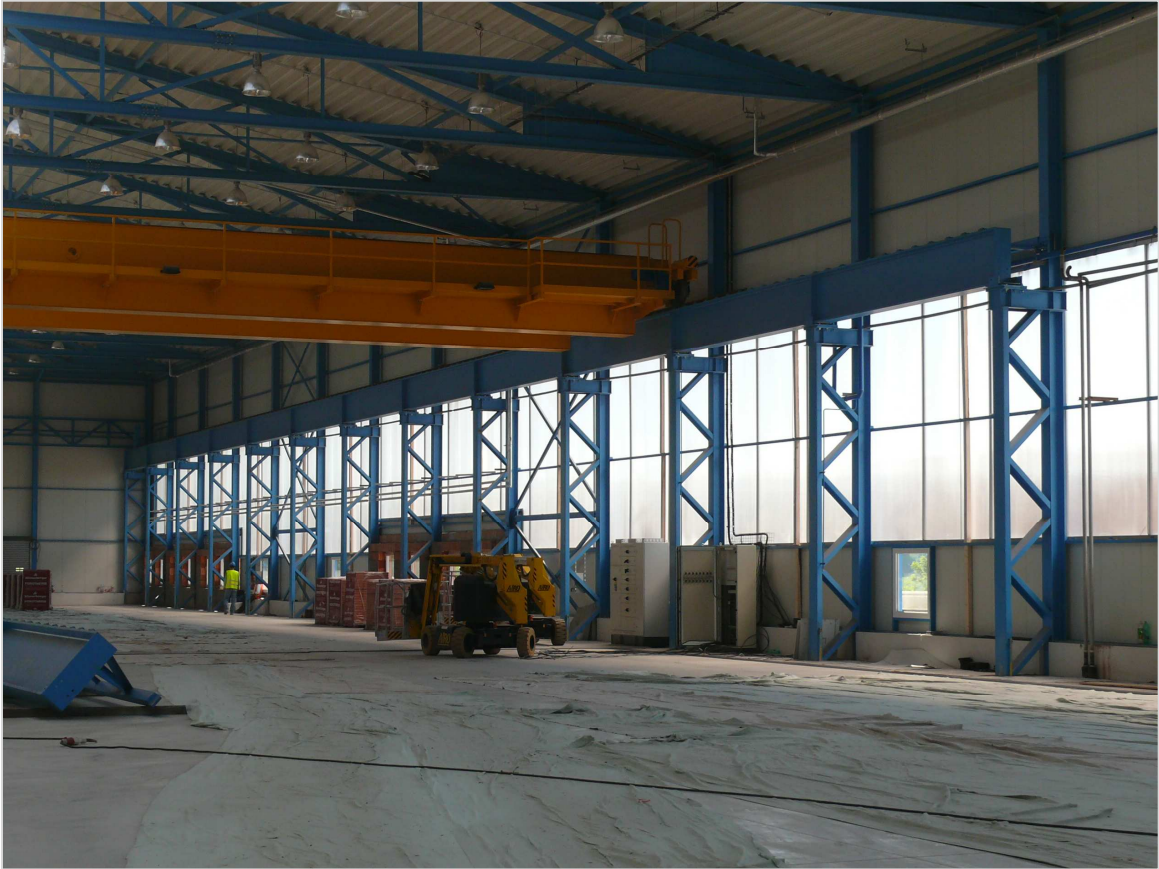
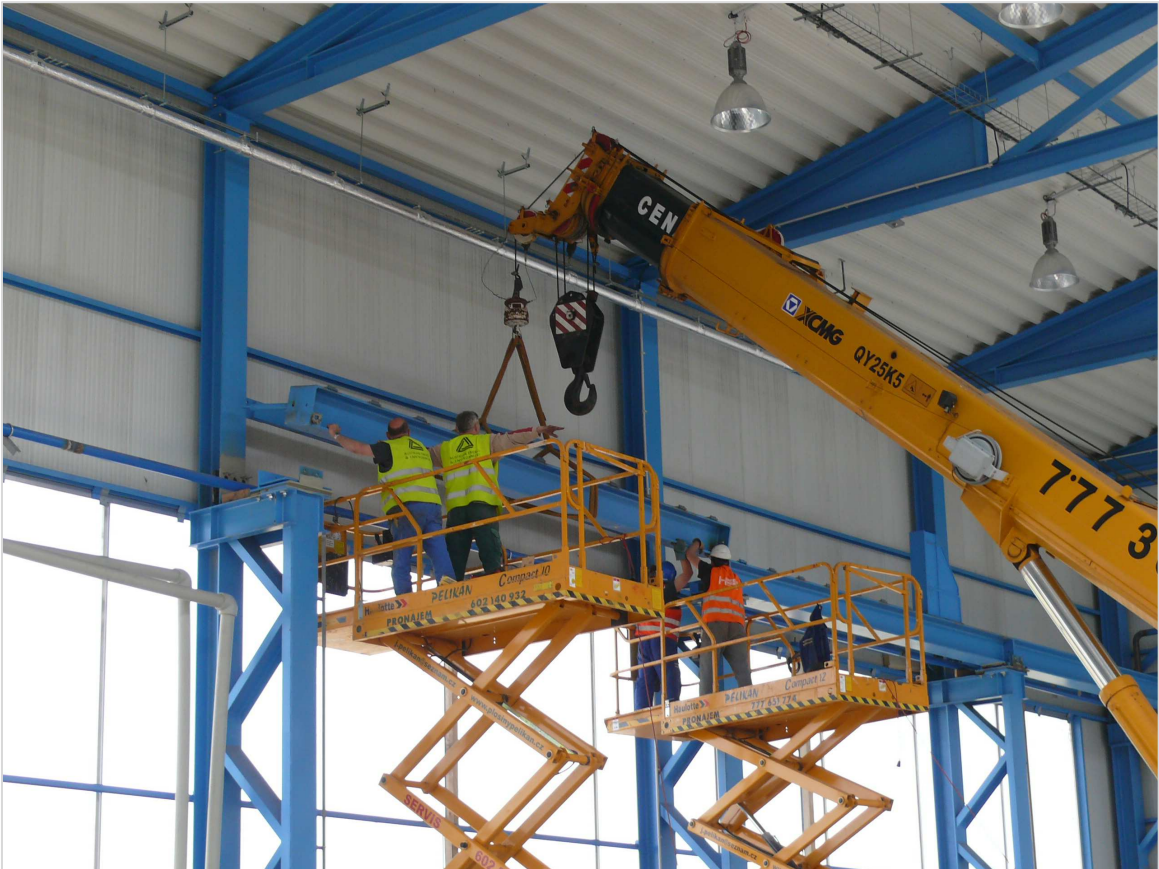
Description: Description: Recalculation of incorrectly designed supporting steel structure of a two-bay production hall with cranes. The original supporting structure design drawn-up by another entity contained errors that were identified during the execution. A detailed design for repair of the entire structure has been prepared while respecting the requirement of minimizing the repair costs and observing the commissioning date. The hall was already assembled and provided with envelope at the time when we started our redesign work. Most repairs were performed at the site. Only the crane track beams with the length of 16m were returned to the bridge building plant for repair. Bridge cranes with the weight of up to 65 tons were installed on the tracks during the repair. It was very difficult to move the cranes during the reconstruction as the rails were at higher elevation after the repair.
